Basement Impact Assessment (BIA)

Swords Road and Santry Avenue, Dublin 9

Report No. B2125-AYE-GEO-R001

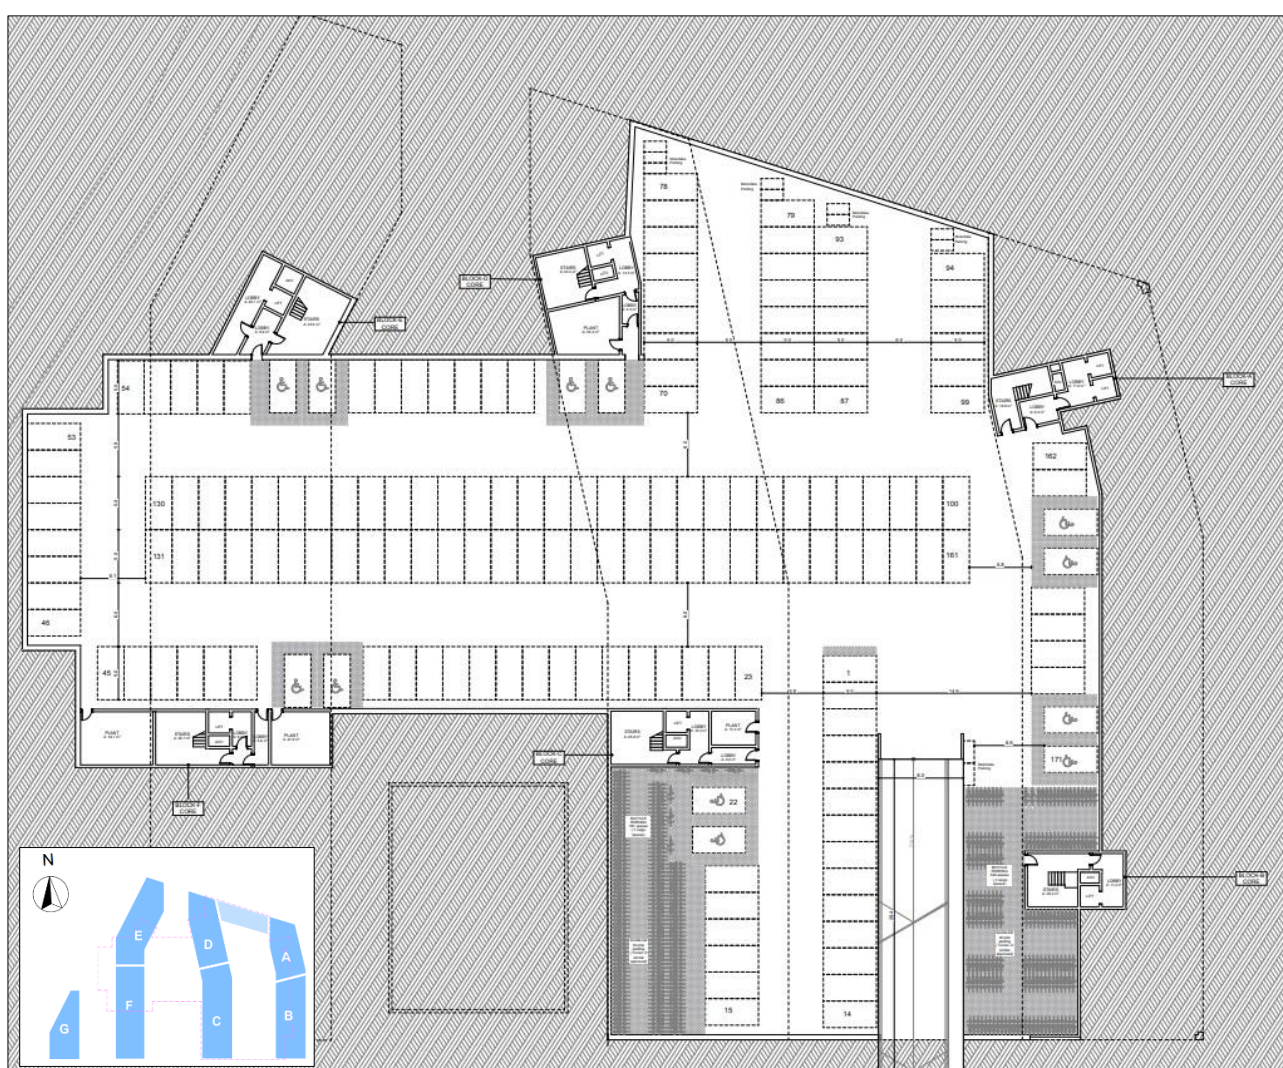
The basement floor plan is displayed in Figure 1.3 below.

Figure 1.3: Basement Floor Plan (ref. Davey & Smith Architects Layout ID: D1809.P05)

The proposed basement area is approximately 87m long and 100m in wide at its furthest extents with a floor level to ceiling height of 2.8m. The excavation of the basement will be 4m BGL and it will be founded in the stiff / very stiff, slightly sandy, slightly gravelly CLAY stratum. The excavated material will consist of MADE GROUND and firm / stiff / very stiff CLAY. This very stiff CLAY material has a very limited ability to transmit groundwater due to its low permeability characteristic and is an aquitard / aquiclude rather than an aquifer. Therefore, the proposed basement is not likely to impede or block groundwater flow as it will be founded within the stiff / very stiff CLAY stratum.

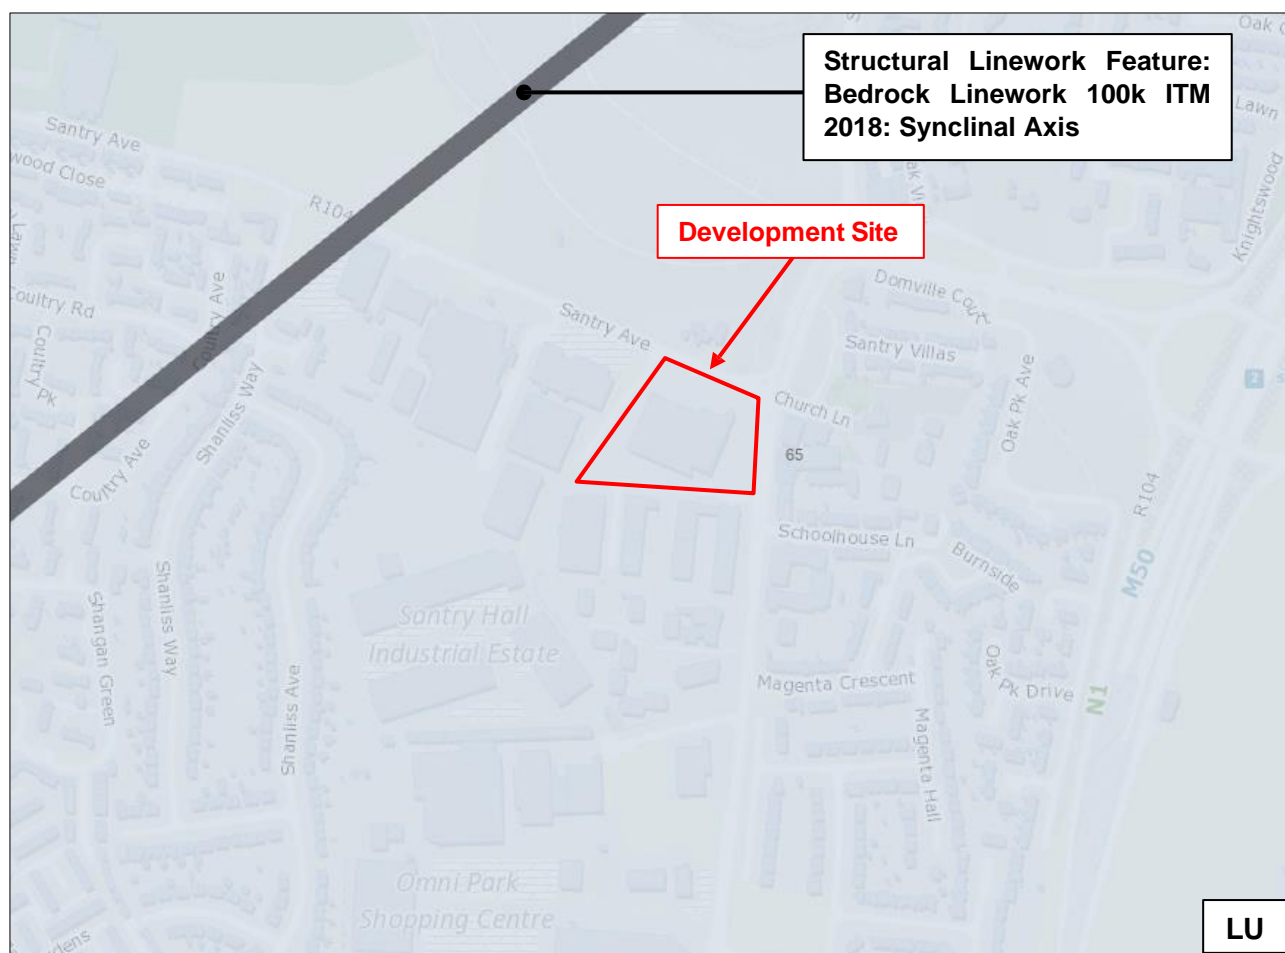
The bedrock geology of site is that of the Lucan Formation (LU), which is described as dark grey argillaceous and cherty limestone and shale. This formation is comprised of dark grey to black, fine-grained, occasionally cherty, micritic limestones that weather paler, usually to pale grey. There are rare dark coarser grained calcarenitic limestones, sometimes graded, and interbedded dark grey calcar. The beds are predominantly fine-grained distal turbidites in the north Dublin Basin. This formation is intermittently exposed on the coast between Rush and Drumanagh Head. It ranges from 300-800m in thickness.

The bedrock geology relative to the development site is detailed in Figure 2.1 below.

Figure 2.1: Bedrock Geology (ref. GSI)

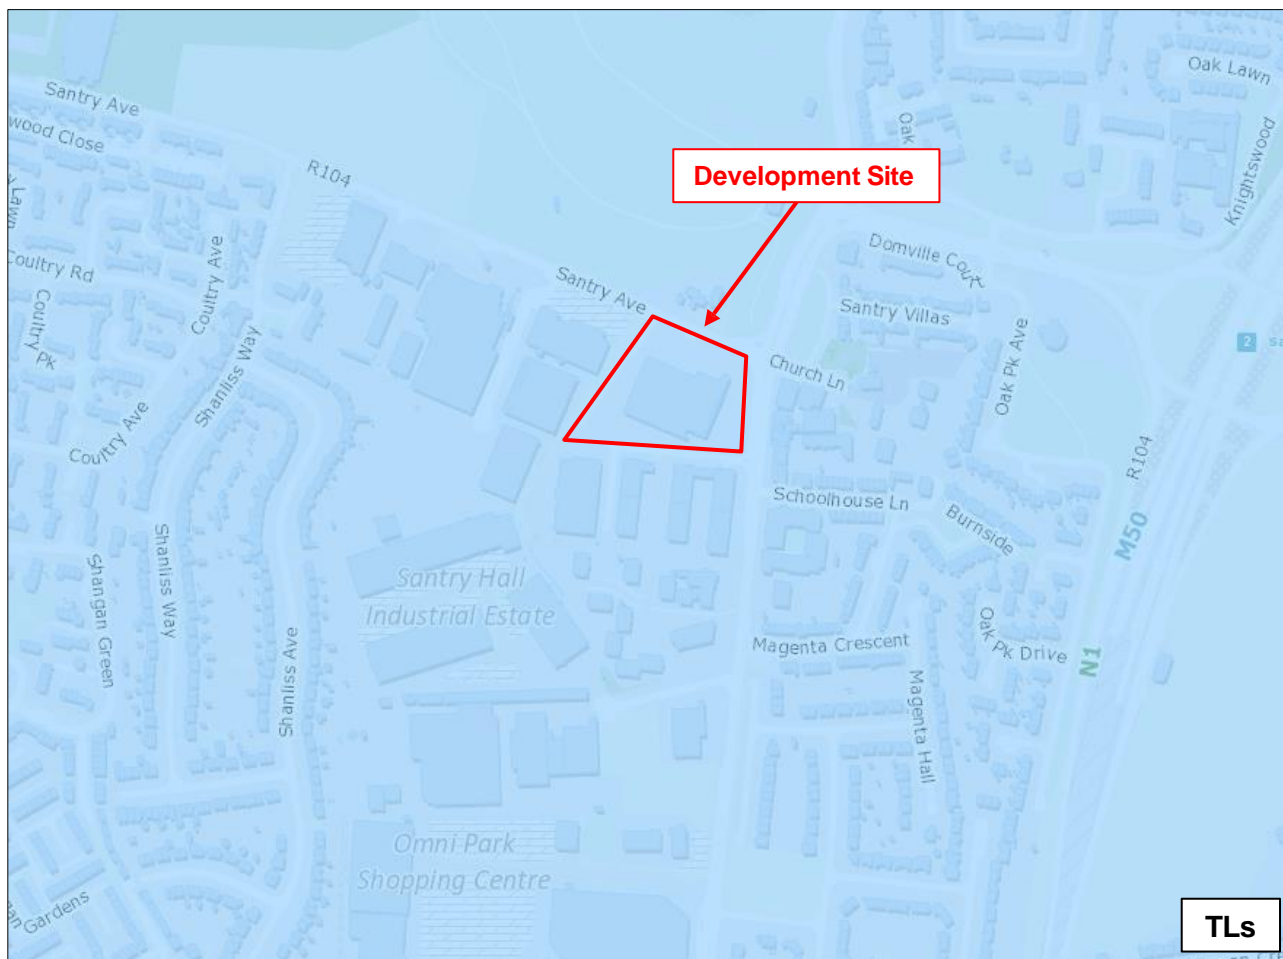
The lithological description of the quaternary sediments is that of Till derived from limestones (TLs).

The quaternary sediments map relative to the development site is detailed in Figure 2.3 below.

Figure 2.3: Quaternary Sediments (ref. GSI)

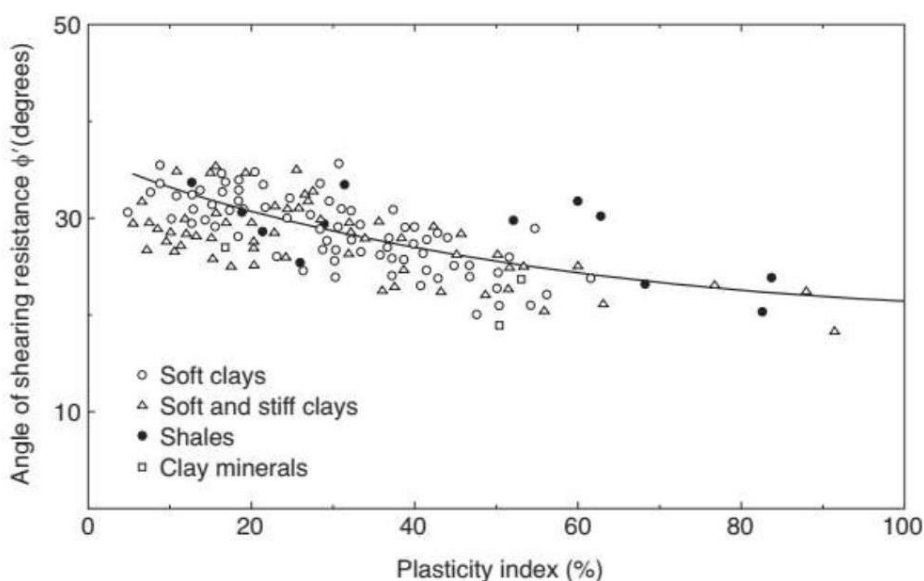
For cohesive soils, an estimation of the angle of shearing resistance ϕ' was developed using the relationship proposed by Terzaghi, Peck and Mesri (1996) as shown in Figure 3.4 below. For high plasticity soils, ϕ' typically varies from 25-30°.

Figure 3.4: Terzaghi, Peck & Mesri (1996)

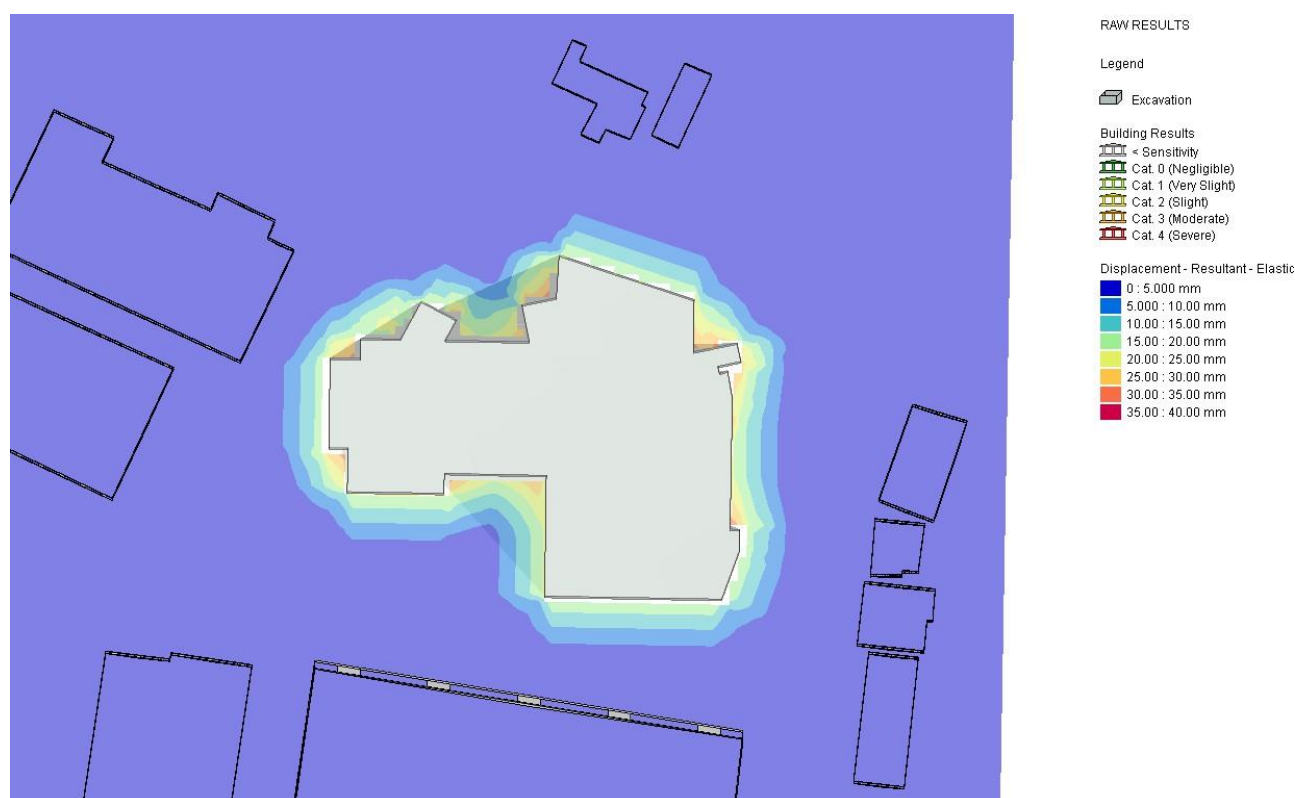
Figure 5.2: Plan of XDisp output of ground movement due to basement excavation

The assessment of ground movements within and surrounding the excavation area has been completed by means of the geotechnical modelling software application OASYS XDisp. This software suite is commonly used within the ground engineering industry and considered to be an appropriate tool for this analysis. The XDisp software has been used to predict ground movements likely to arise from the construction of the proposed basement. This includes the settlement of the ground in the form of vertical movement and the lateral or horizontal movement of the soil caused by the excavation.

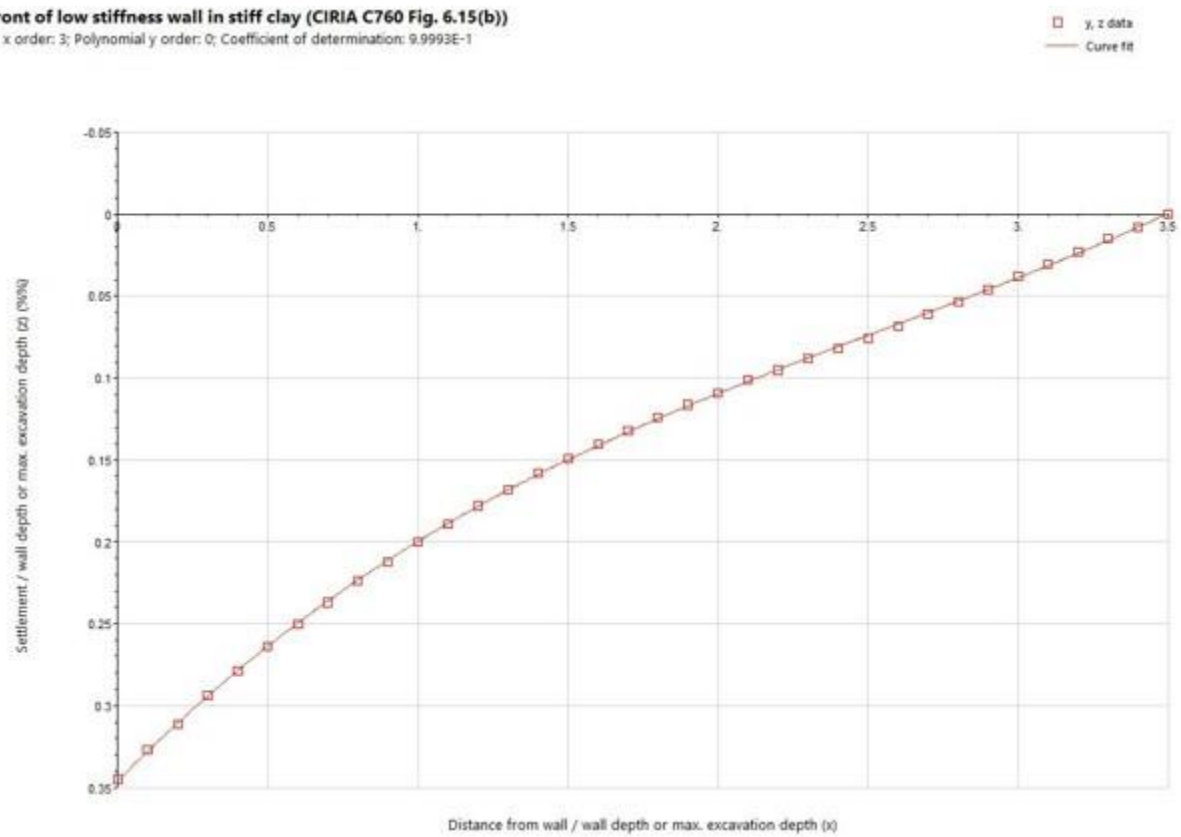
Exc. in front of low stiffness wall in stiff clay (CIRIA C760 Fig. 6.15(b))
Polynomial x order: 3; Polynomial y order: 0; Coefficient of determination: 9.9993E-1

- *Ground movements surrounding the basement:* It is proposed to install a secant piled wall to facilitate the construction of the basement. Ayesa has completed an assessment of the ground movements based on that of the excavation in front of a low stiffness wall (CIRIA C760 Fig. 6.15 (b)). These were derived from a number of historic case studies.

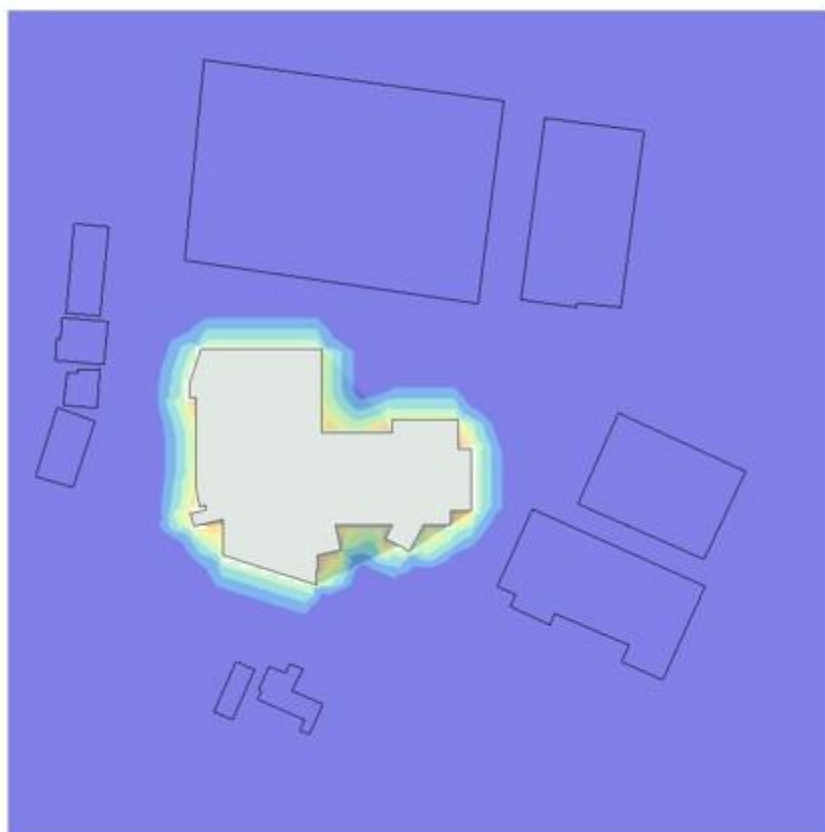
Displacement - Resultant - Elastic

- 0 : 5.000 mm
- 5.000 : 10.00 mm
- 10.00 : 15.00 mm
- 15.00 : 20.00 mm
- 20.00 : 25.00 mm
- 25.00 : 30.00 mm
- 30.00 : 35.00 mm
- 35.00 : 40.00 mm
